Manhole Inspection Summary

Manhole # S41CC_034MH

Insp Date: **11/10/08 2:46 PM**

Location Address: **rear 932 n central av**

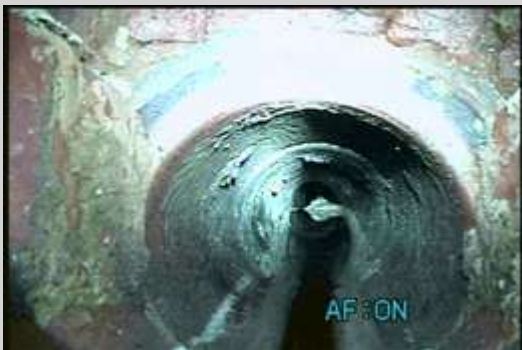
12 O'Clock Outflow

8 in. Circular Gravity Sewer
Pipe Out @ 12 O'Clock

Invert Depth: **12.16** (ft.) Flow Characteristics: **Slow**

Deposits: ☒ None ☐ Mud ☐ Sludge ☐ Debris ☐ Grease

Infiltration: **None** Pipe Seal Cond: **Unknown**

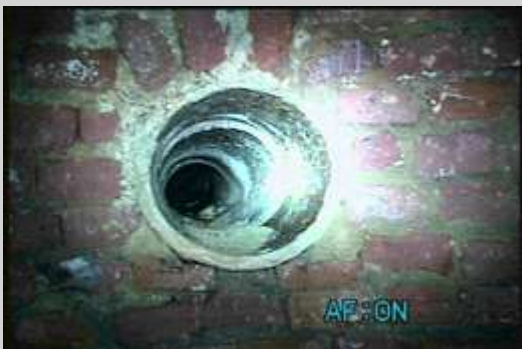
3 O'Clock Inflow

8 in. Circular Gravity Sewer
Pipe In @ 3 O'Clock

Invert Depth: **9.83** (ft.) Flow Characteristics: **None**

Infiltration: **None** Pipe Seal Cond: **Unknown**

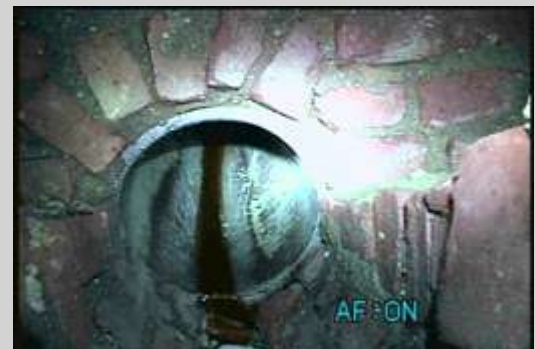
Drop In @ 3 O'Clock

Drop: **Outside Direct**

Inv Depth: **11.88** (ft.)

Drop Condition: **Open**

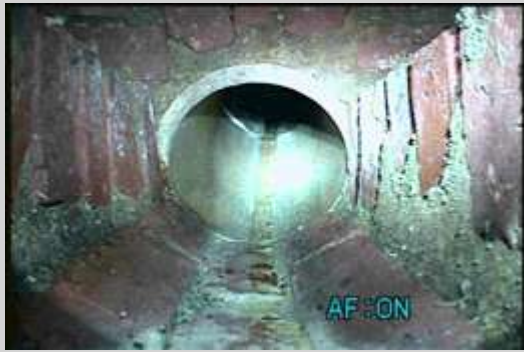
6 O'Clock Inflow

Pipe In @ 6 O'Clock

Invert Depth: **11.79** (ft.) Flow Characteristics: **None**

Infiltration: **None**

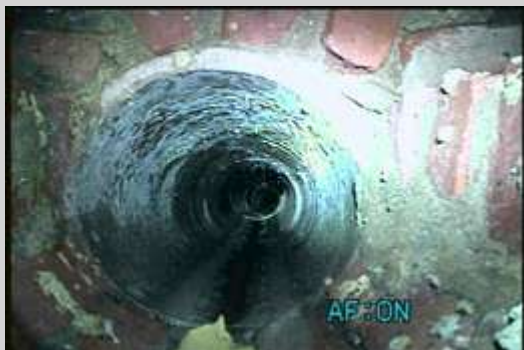
9 O'Clock Inflow

Pipe In @ 9 O'Clock

Infiltration: **None**
